# TOWN OF MANLIUS

## BUILDING ASSESSMENT

**Building Assessment:**

Project: Town of Manlius Town Hall

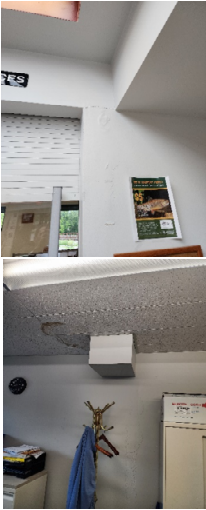
| Item # | Section | Item/Image | Observation | Good | Fair | Poor | Very Poor | Non Compliant | Recommendation | Estimated Cost |
|---|---|---|---|---|---|---|---|---|---|---|
| 27 | Building Interior | | Rainwater leaders leaking in multiple locations, damaging drywall and ceilings | | | | | x | Replace roof drains, rainwater leaders, and any other accessories as necessary | \$ 65,000 |
