# TOWN OF MANLIUS

## BUILDING ASSESSMENT

Project: Town of Manlius Town Hall

Number: 24-5808

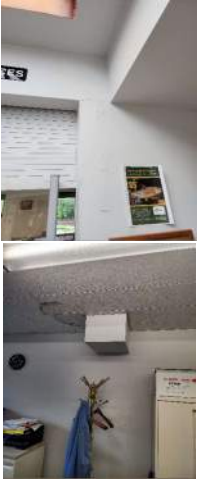
| Item # | Section | Item/Image | Observation | Good | Fair | Poor | Very Poor | Non Compliant | Recommendation | Estimated Cost | Priority |
|---|---|---|---|---|---|---|---|---|---|---|---|
| 27 | Building Interior | | Rainwater leaders leaking in multiple locations, damaging drywall and ceilings | | | | | x | Replace roof drains, rainwater leaders, and any other accessories as necessary | \$ 65,000 | |
