Town of Manlius New Municipal Building

LOOKING AT THE 2018
FEASIBILITY STUDY,
UPDATES FROM 2024,
AND
WHERE WE'RE GOING

2018 Feasibility Study

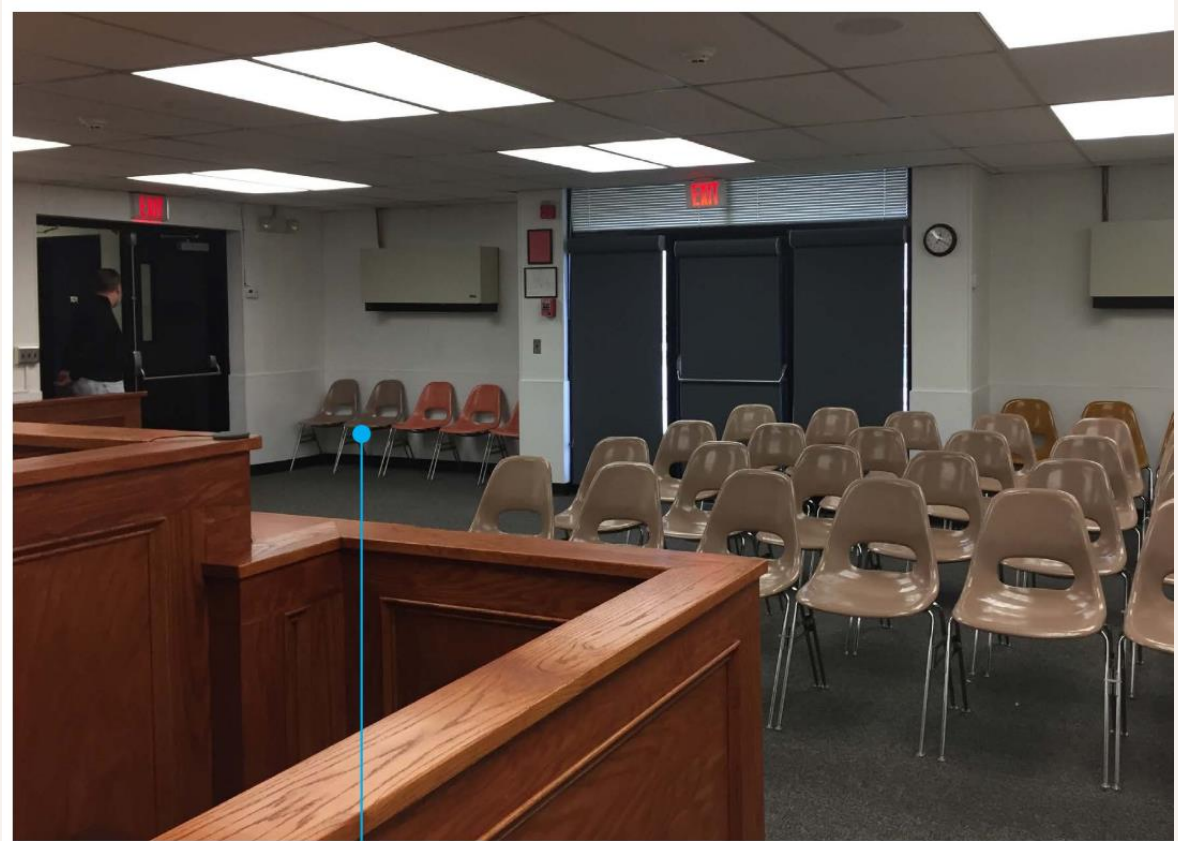
COURT INTERIOR: PRISONERS CURRENTLY SIT IN THE BACK OF THE ROOM, WHICH IS A SECURITY CONCERN; THEY SHOULD BE LOCATED BEHIND A PARTIAL HEIGHT WALL WITH THEIR OWN ENTRY, ADJACENT TO THE STAND (SEE LANCASTER PROJECT AS PRECEDENT EXAMPLE).

- Given the increased volume of cases, the court does not have enough capacity.
- The layout leads to poor safety for everyone in attendance and is challenging for remote hearings.
- Recent issues with utilities.

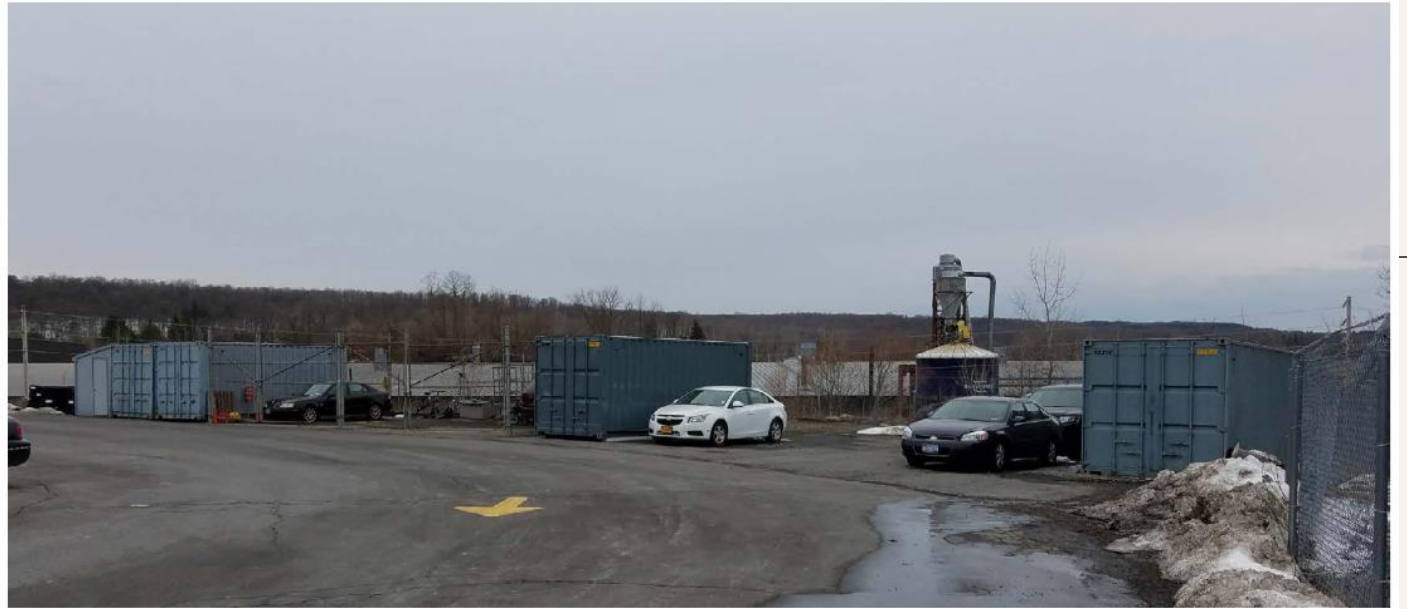
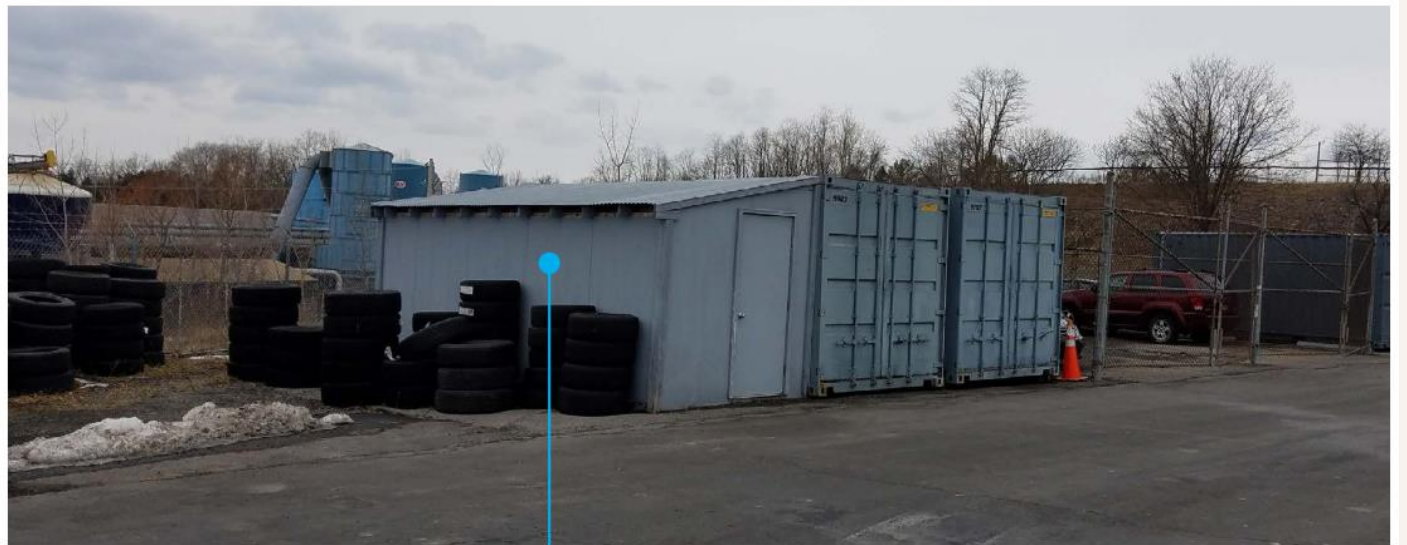
- Due to space limitations, the Police Department has had to use storage containers in the parking lot. This presents additional security concerns and highlights the lack of adequate space for the department's operations.

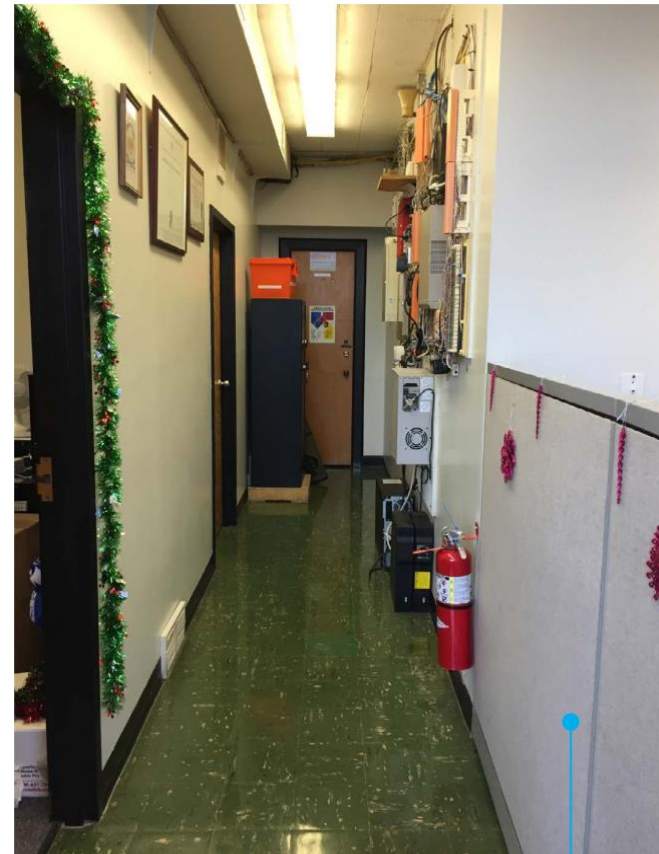
POWER SOURCE WITH NO REDUNDANCIES WITHIN BUILDING ; ADMINISTRATION WORK AREA IS VERY CRAMPED WITH NOT ENOUGH STORAGE.

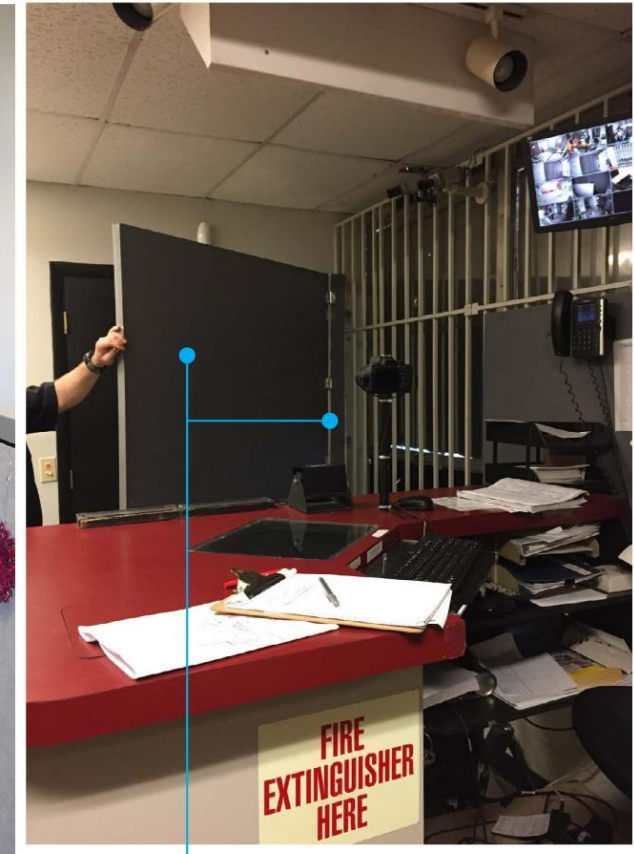
BOOKING AREA: LACK OF SPACE AND STORAGE IN BOOKING AREA; NO SPACE TO PHOTOGRAPH (CURRENTLY A MOVABLE DOOR IN FRONT OF BATHROOM).

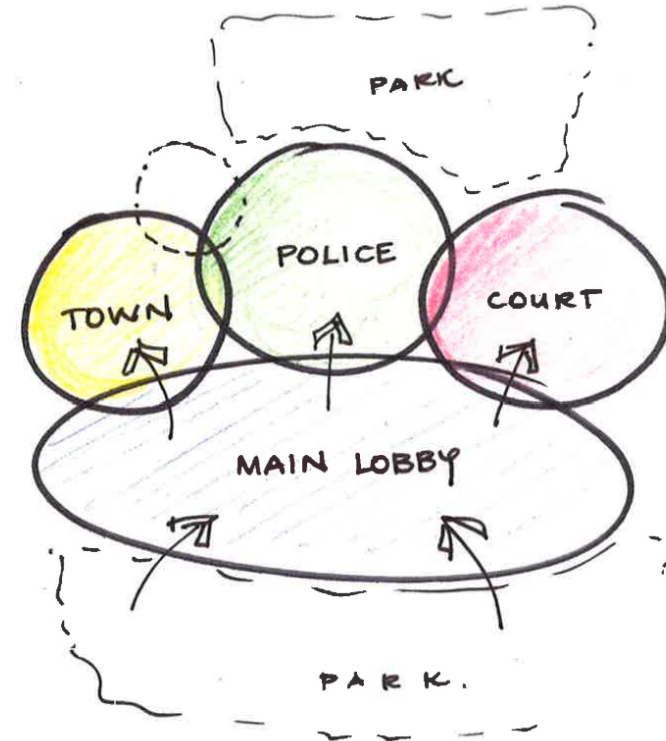
▲ EARLY CONCEPT SKETCH ABOUT POTENTIAL BUILDING ORGANIZATION W/ SHARED POINT OF ENTRY AND COMMON SPACE.

- + Main Lobby/Entry (single entry for all sectors)
- + Multi-Purpose Room for: Police/Town Board Meetings; Public Use; Recreation
- + Combined Kitchen/Break for Town & Police Staff
- + Fitness Center for Town & Police Staff
